**Docket No. 217 – Development and Management Plan Inspection**

Northeast Utilities Service Company Certificate of Environmental Compatibility and Public Need for the construction of a 345-kV electric transmission line and reconstruction of an existing 115-kV electric transmission line between Connecticut Light and Power Company's Plumtree Substation in Bethel, through the towns of Redding, Weston, and Wilton, and to the Norwalk Substation in Norwalk, Connecticut.

**Date:** June 9, 2005

**Location:** Norwalk Substation Expansion

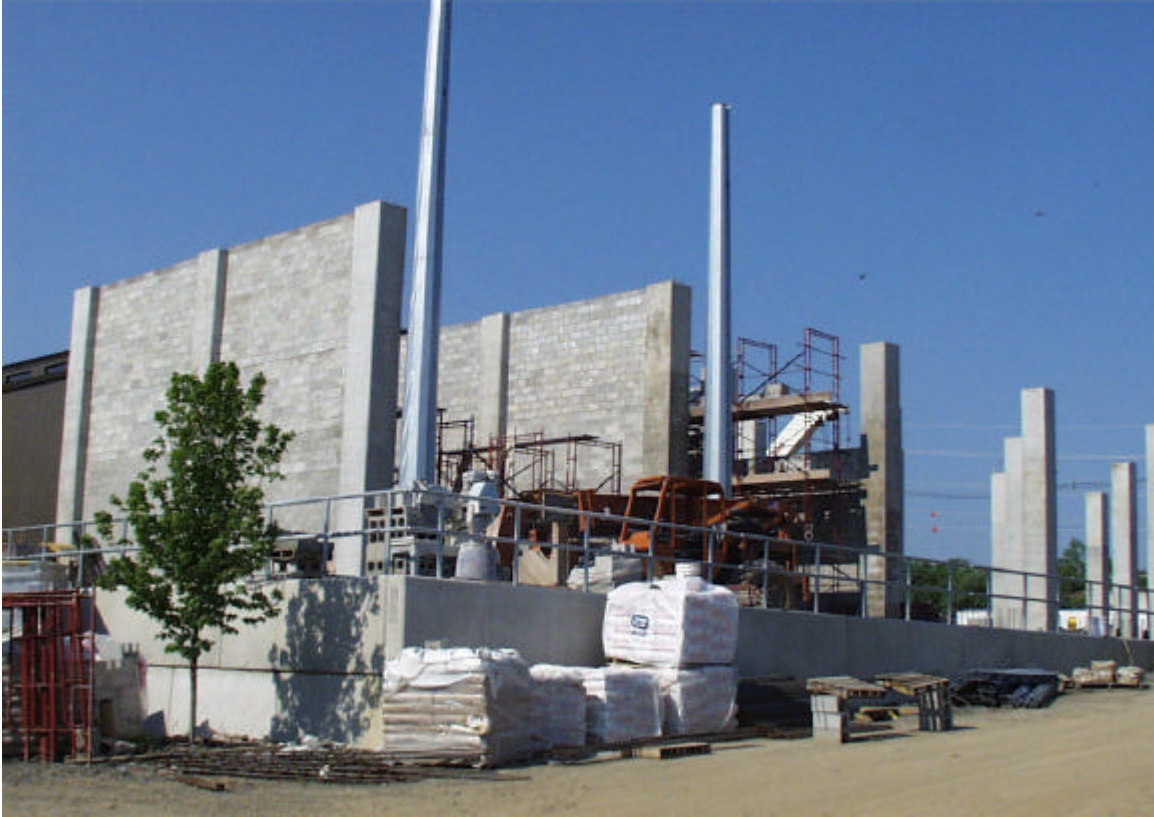
Norwalk Substation- Structure work continues in front of the GIS building. 6/9/05

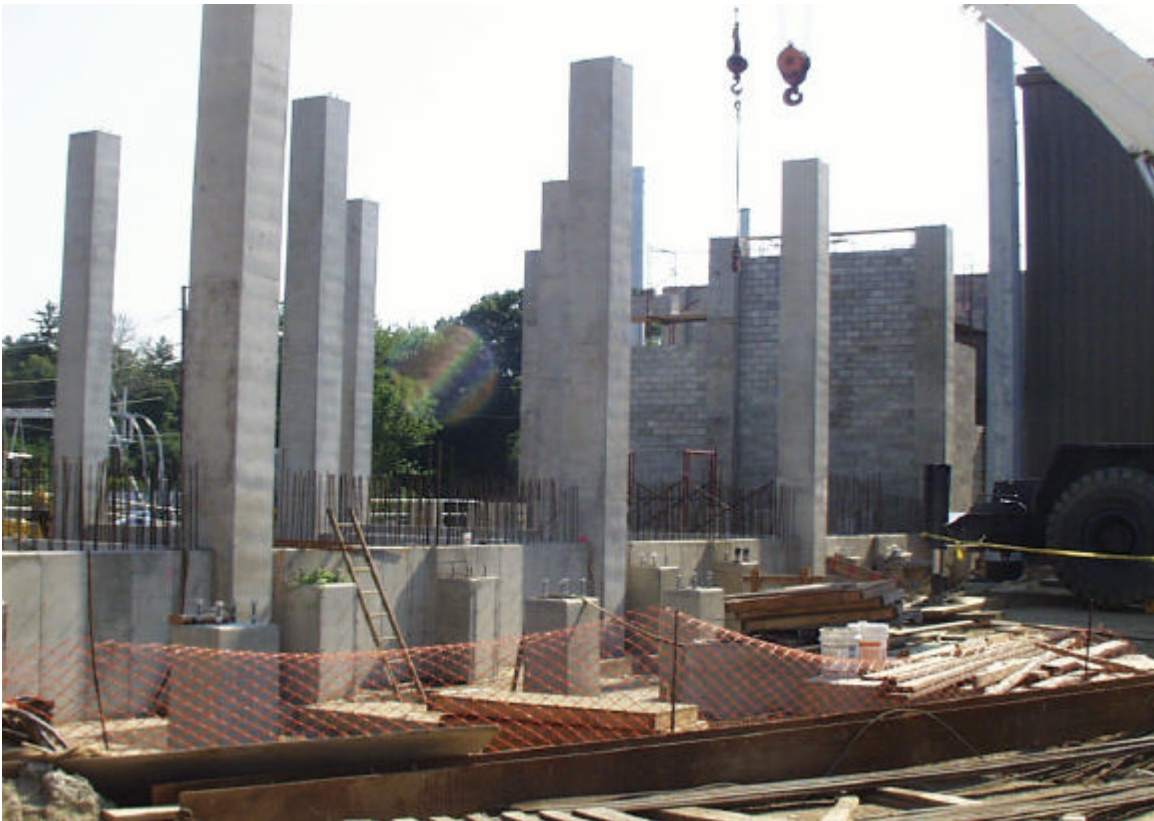
| Areas of Inspection | Observation | Recommended Action |
|---|--|---|
| Foundation construction | <ul style="list-style-type: none"> <li>- Soil from the stockpile was being used in front of the GIS building for backfill. 6/01-6/09/05</li> <li>- Work on the structures near retaining wall #3 and the control house is ongoing, including rebar installation. 6/01-6/09/05</li> </ul> | <ul style="list-style-type: none"> <li>- None at this time. 6/09/05</li> <li>- The excavation and work is well within the yard and areas are contained, no issues at this time. 6/09/05</li> </ul> |

Overall view of the stone/concrete and foundation work adjacent to the GIS building. 6/9/05

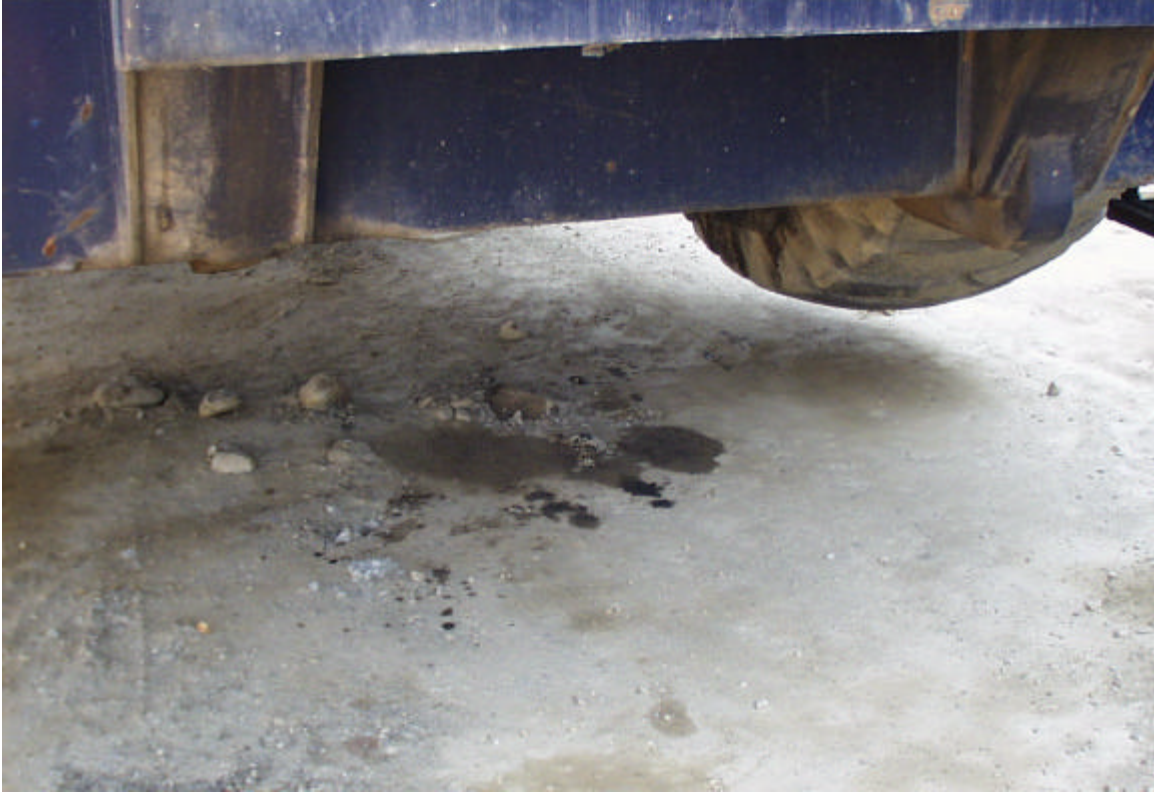
| Areas of Inspection | Observation | Recommended Action |
|---|---|--|
| Spills and Material Storage | <p>- The crane has been located in a stationary position for several weeks. Absorbent pads were removed at the time of the inspection but a drip was still present. The soil should be picked up and pads replaced. A mechanic should evaluate the equipment. 6/09/05</p> <p>- The areas noted last week had been cleaned up and the soil was removed. The only other spot noted was a possible fuel overspill on a (people) lift 6/09/05</p> | <p>- The contractors should remain vigilant about securing and handling fuel containers due to the sensitivity of the area.</p> <p>- Continue to keep all vehicles maintained well (i.e. no apparent fluid leaks) if they will be used or stored on site. -</p> <p>- Check equipment status on a regular basis.</p> <p>- Report spills to the office immediately, even if they are being controlled.</p> |

A small drip from the crane was noted again but absorbent pads were not in place at the time.  
6/9/05

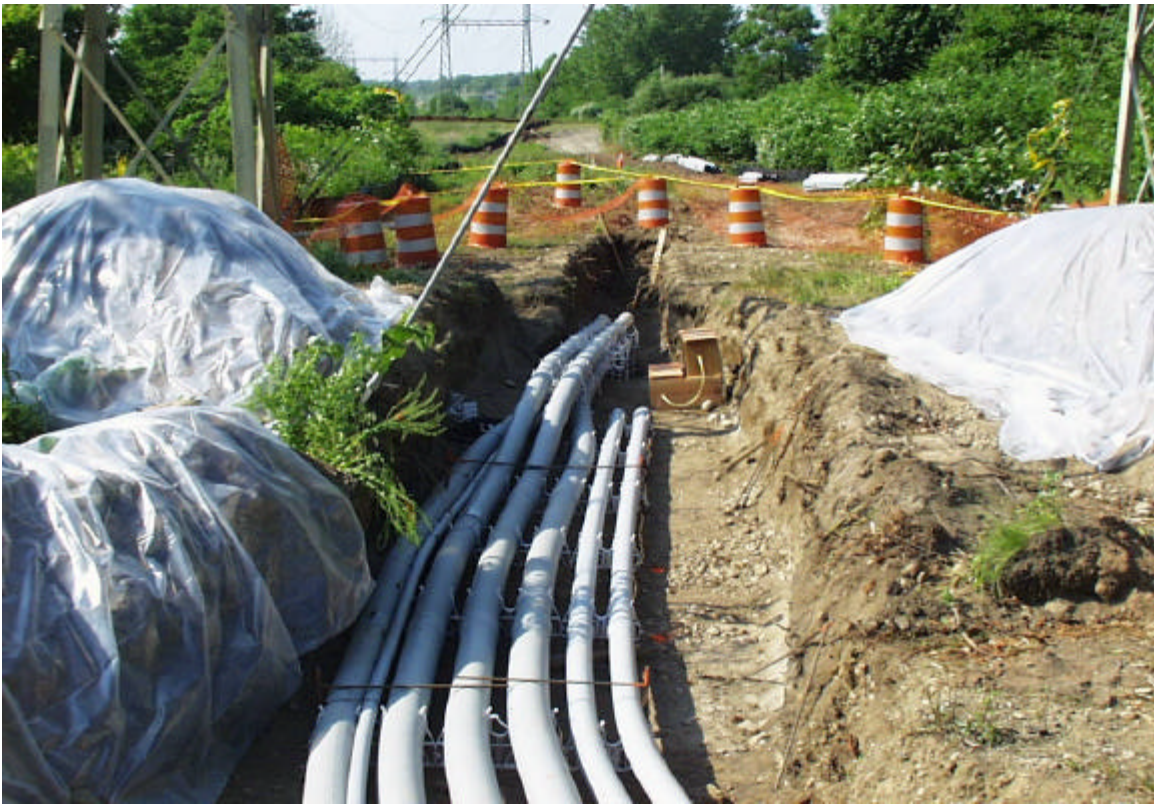
| Areas of Inspection | Observation | Recommended Action |
|---|---|--|
| Additional Observations | - Work for the 115kV line has started to the north of the substation fence. Active trenching and conduit installation has begun in the existing ROW here. Silt fence is well in place. 6/09/05 | - None at this time. |

View of the 115kV work leading from the Norwalk substation in the existing right-of-way. 6/9/05

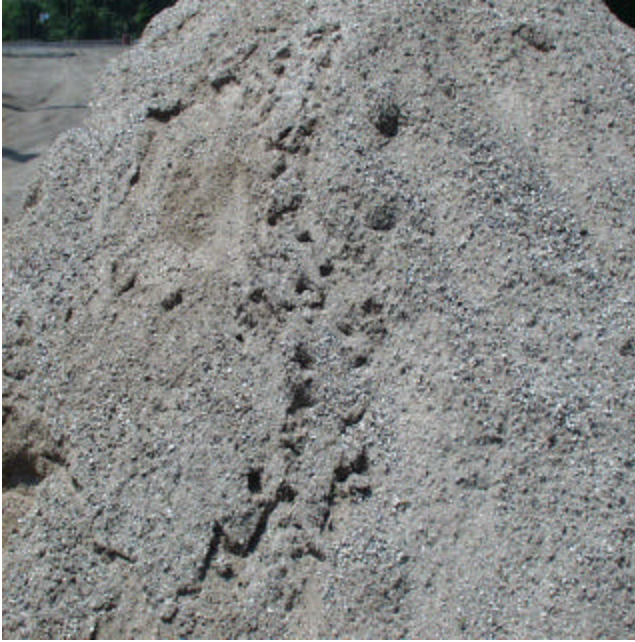
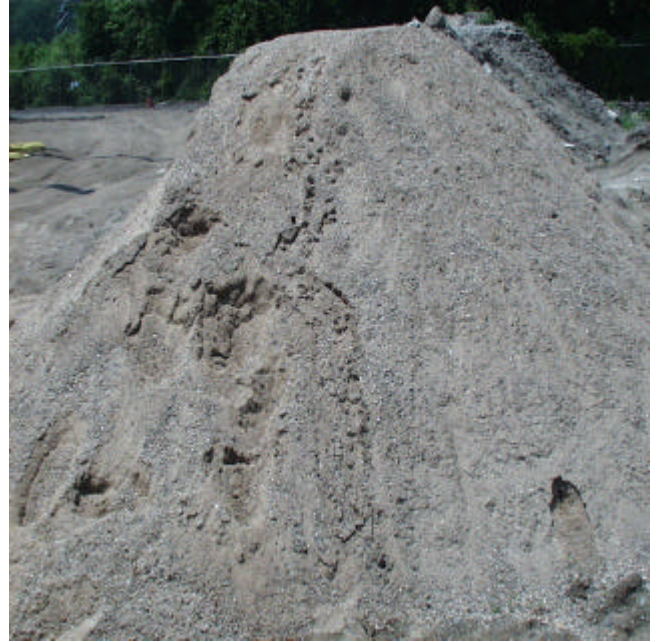
| Areas of Inspection | Observation | Recommended Action |
|--|---|--|
| State species of concern, threatened and endangered species | - The morning of the inspection, we noted turtle tracks up the side of a soft sand pile in the yard. One area appeared that a nest had been prepared however we did not confirm the presence of eggs. 6/09/05 | - The pile was encircled with safety/snow fence and will not be moved for several months in the chance eggs are incubating here. 6/09/05<br>- Everyone at the substation also remains aware and will move machinery carefully in case the individual turtle returns. |

Plumtree Substation: Turtle tracks were noted along the sand pile remaining in the yard. It is likely that the wood turtle made a nest here. The pile was surrounded by safety/snow fence and will not be removed. 6/9/05

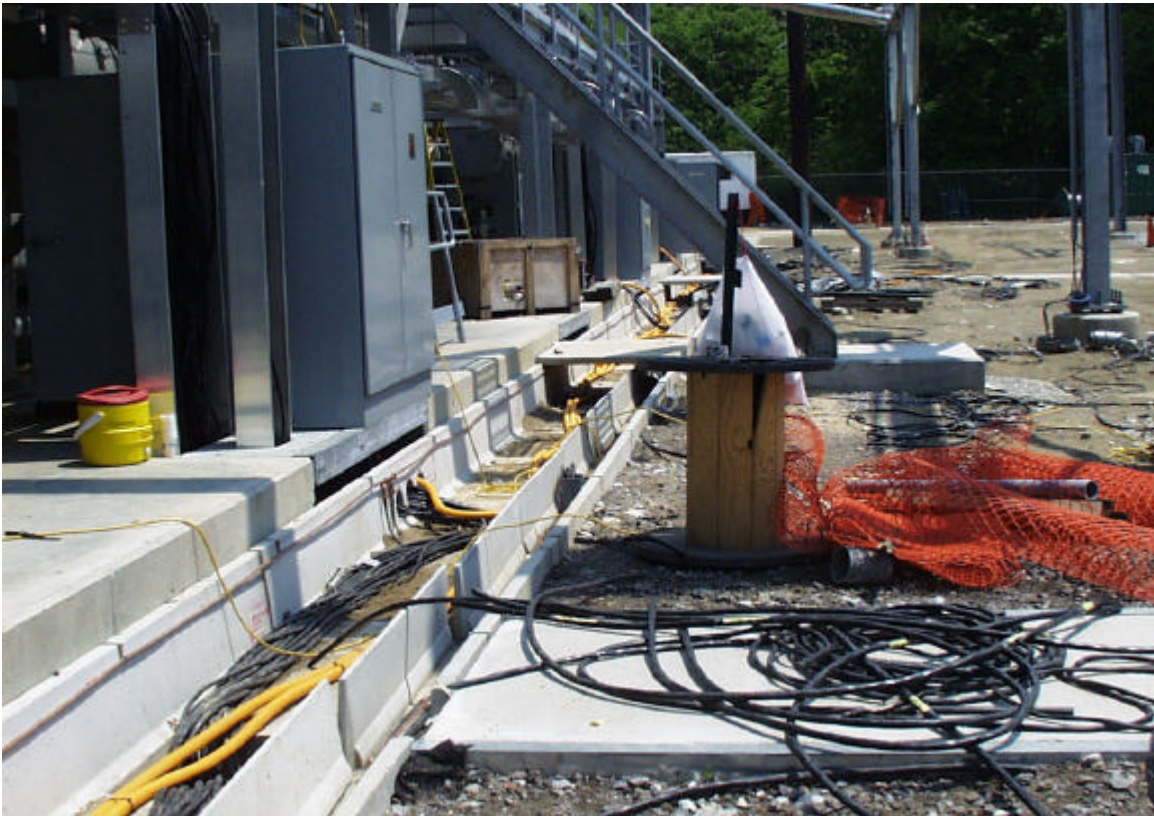
| Areas of Inspection | Observation | Recommended Action |
|---|--|---|
| Foundation construction | -The remaining work is mostly electrical, connecting and circuiting the new equipment. 6/09/05<br>- The trenches have remained open but underground cable pulls are complete for the most part. Active pulls are finishing up near the control house. No soil movement is involved and the concrete trench lids will be closed soon. 6/09/05 | - The areas are all contained at this time and there is little ongoing work that involves soil disturbance. 4/6-6/09/05 |

Cable pulling is complete in most areas and trenches will be covered in the future. 6/9/05
